Privileged and Confidential
Prepared at the Request of Consul
Alaska Pacific Powder Site
Mark Johns
December 20, 1994

The following information pertains to photographs taken by Mark Johns while on a site visit to Pacific Powder Site on December 20, 1994. The text is annotated with references specific items detailed in the letter dated August 5, 1994, from Mark Johns to Mr. James Ragen.

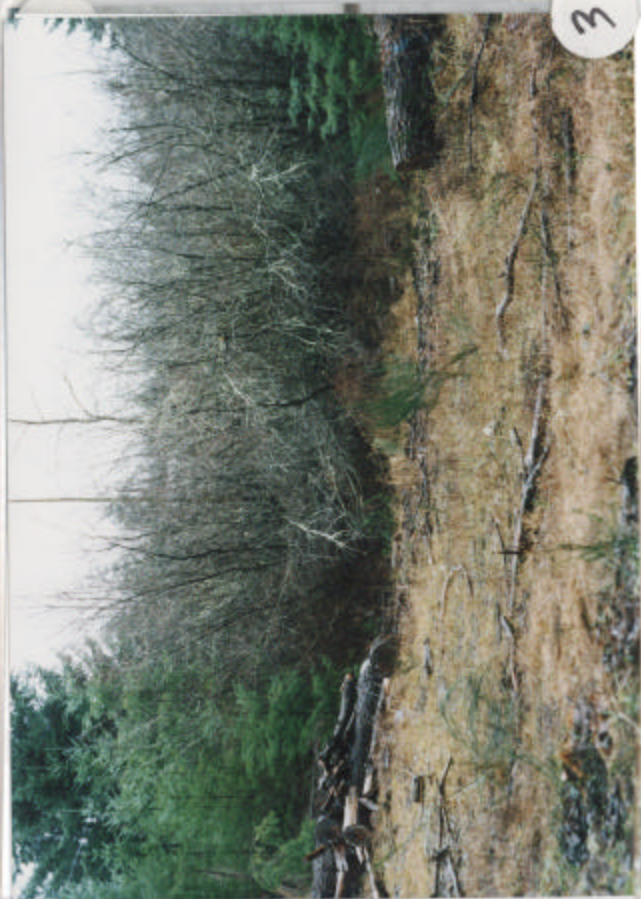
3

Photo No.	Description
(1)	Site of old trailer near entrance to site, trash.
(2)	Site of old trailer near entrance to site, well house.
(3)	Pit located on first right turn, dirt road to pit with logs. Area just west of Culvert yard, under power lines, old dump with wood debris and area that looks like an old bunker.
(4, 5, 6)	Back of Culvert yard looking toward road.

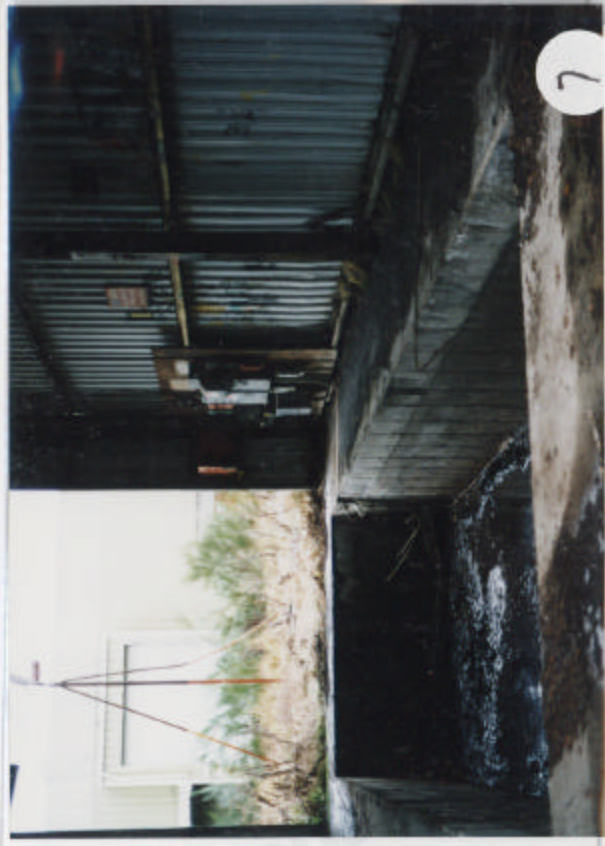
7

(7)	Inside dipping plant, no additional work has been performed.
(8)	Corrugated garage south of dipping plant with electrical boxes.
(9)	Oil sheen on main garage floor.

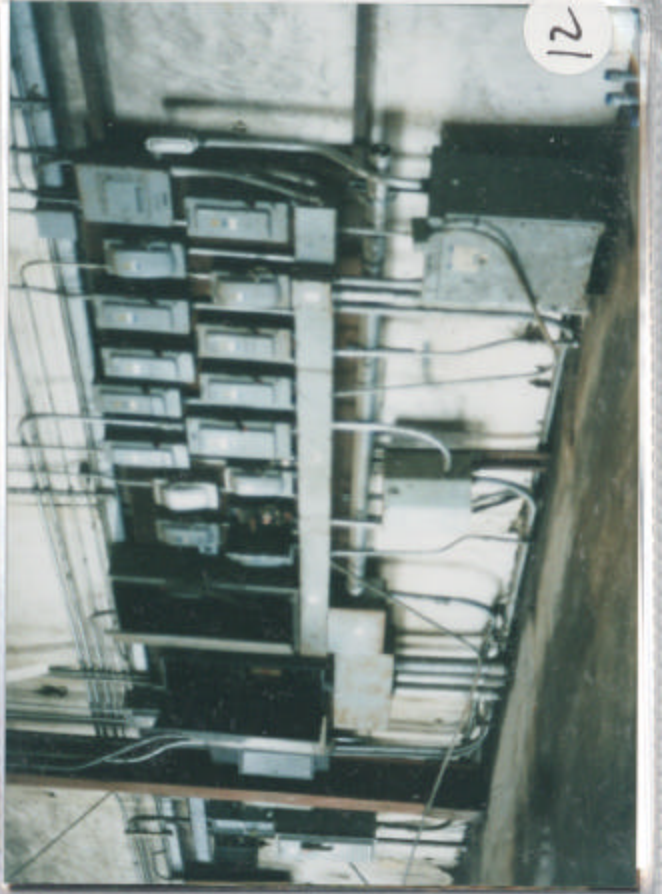
11

(10)	Main work garage - empty shop.
(11)	Main work garage - electrical boxes.
(12)	Main work garage - electrical boxes.
(13) <i>East</i>	West side of culvert yard, visqueen pile, oily sheen.
